Cob Construction in Italy: Some Lessons from the Past

Enrico Quagliarini ^{1,*}, Alessandro Stazi ¹, Erio Pasqualini ² and Evelina Fratolocchi ²

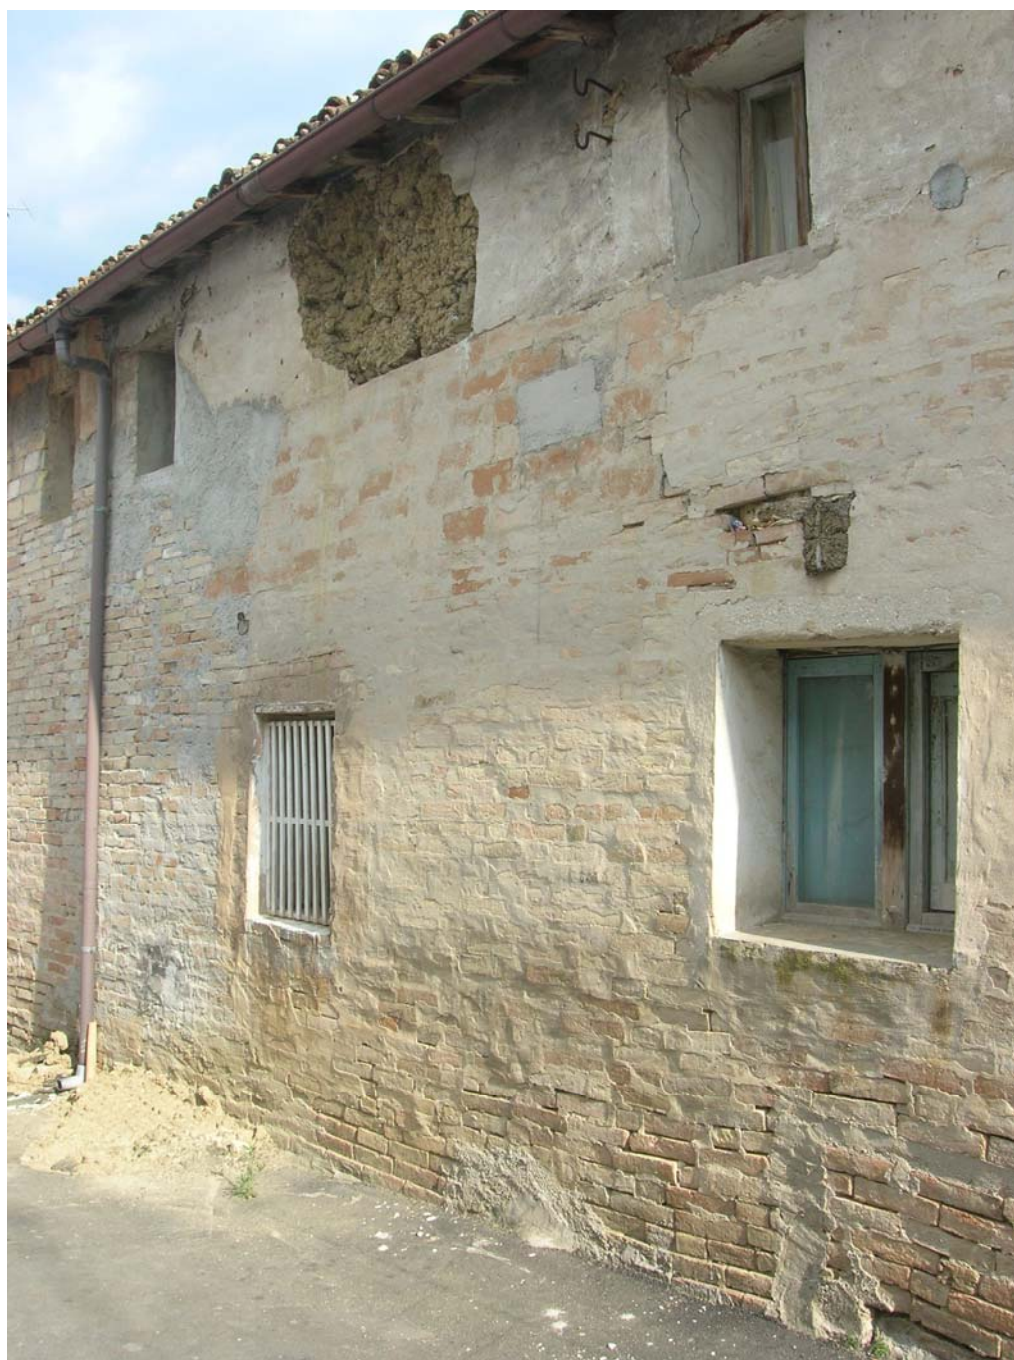
Figure 3. Raw-earth cob walls are often safeguarded by a thick earthen plaster or by a layer of fired bricks.

The thickness of the earthen walls is about 1–1.10 m on the ground floor and from 0.60 to 1.10 m on the first floor, and the windows are small in order to reduce heat dispersion and water infiltration. In some houses there are also walls made by fired bricks. Several earthen walls were built above a masonry base which has a height of about 0.40–0.50 m. This allowed the wall to resist excessive vulnerability with respect to ground surface erosion and water absorption. Earthen wall external surfaces are sometimes safeguarded by a 0.05–0.10 m earthen plaster or a common vertical brick layer (Figure 3).

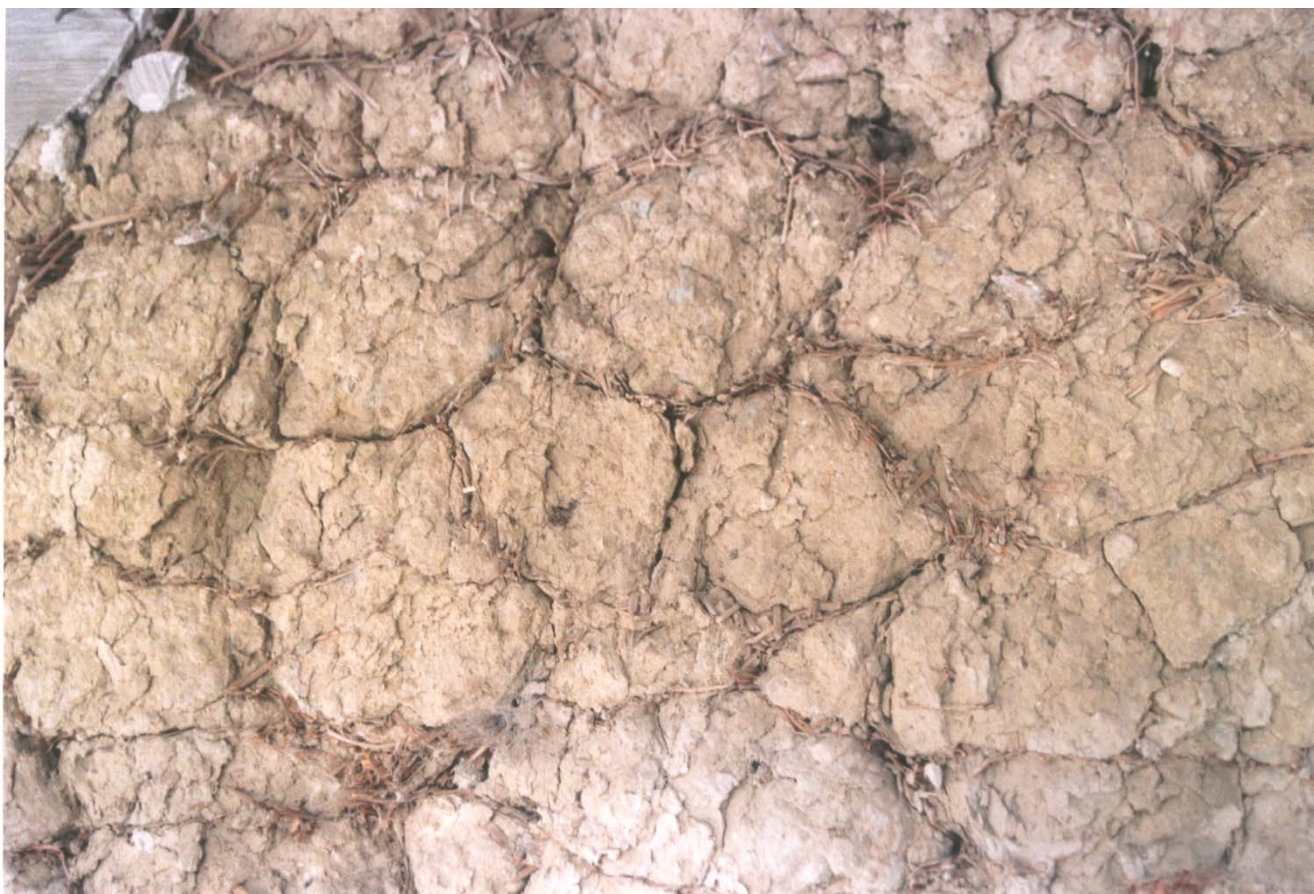
Figure 4. An external wall reveals the presence of cob bricks covered by straw.

Processing the acquired data during accurate surveys and subsequently by laboratory analysis carried out on these earth buildings, it was possible to identify—as first results—the technique used to construct the earthen walls. The technique is similar to the one commonly called “bauge” in France or “cob” in the United Kingdom. Large cylinder-shaped “bricks” (cob bricks) can be in fact easily recognized (Figure 4). They are more or less compressed due to the construction of the wall which bears its own weight. Each base element, or cob brick, is called “massone” in jargon by local inhabitants.

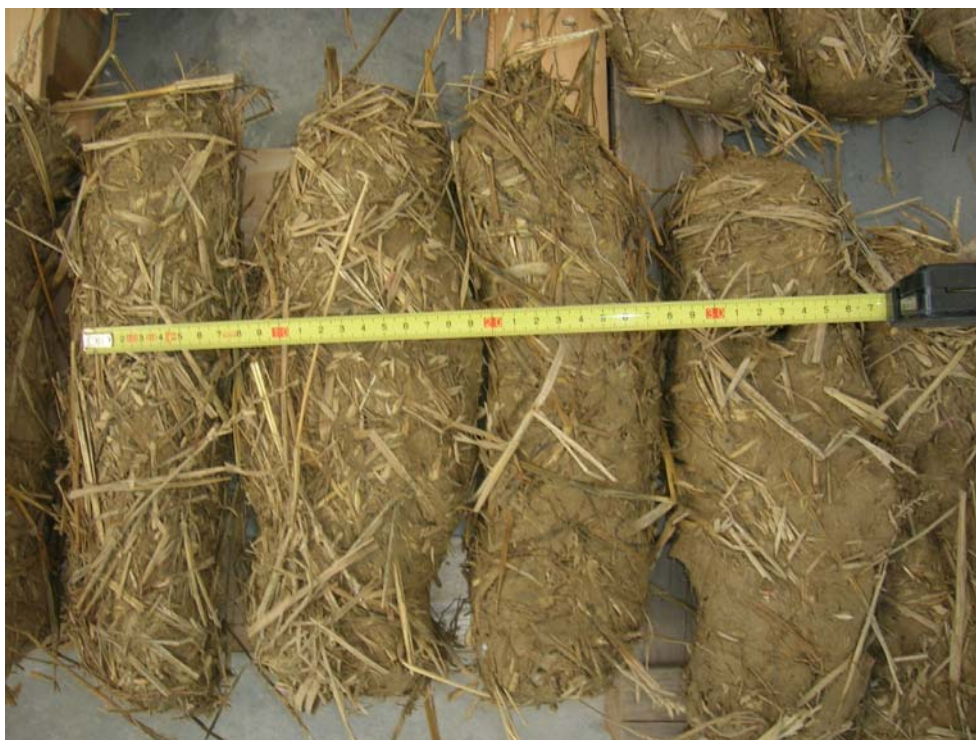
Figure 6. Some cob bricks made by yellow soil.

In this way, about 210 cob bricks were manufactured (Figure 6) and seven earthen walls were made.

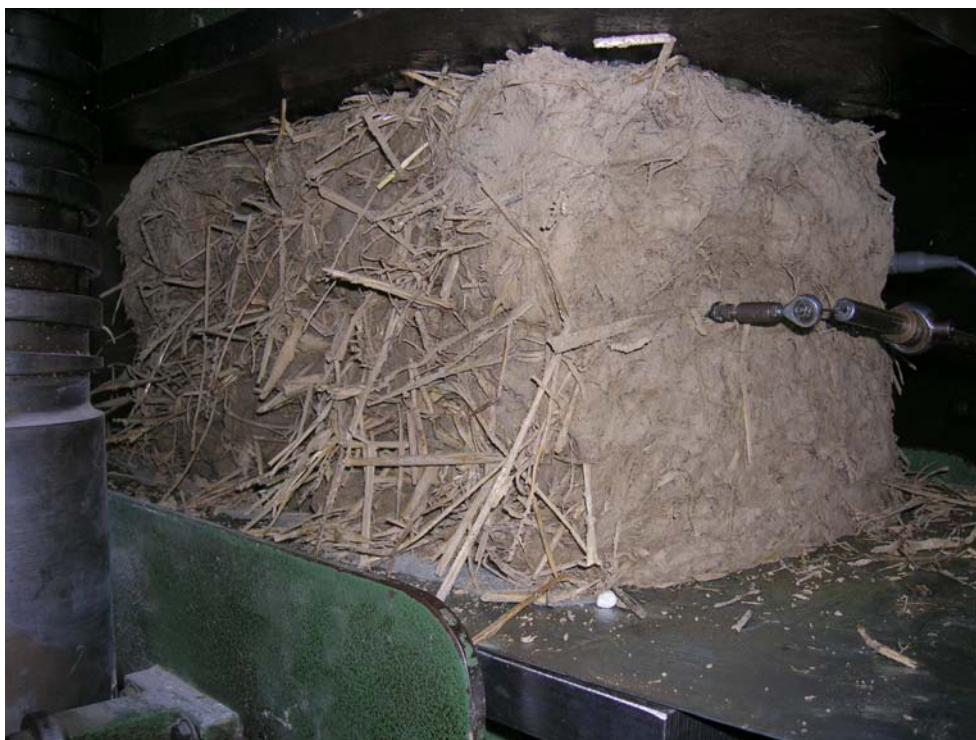
Figure 7. A raw-earth cob sample tested by uniaxial compression.

Compression tests were set to allow uniform distribution of stresses on specimens. For this purpose, each specimen was inserted between a lower and an upper steel plate sprinkled by fat in order to reduce friction. All the samples were tested along the direction they generally withstood loads. The apparatus used for the compression tests was a first class “Metrocom MI 300” with a 1% error and with an end scale of 3,000 kN. It had two transducers: one for pressure and one for vertical displacement.

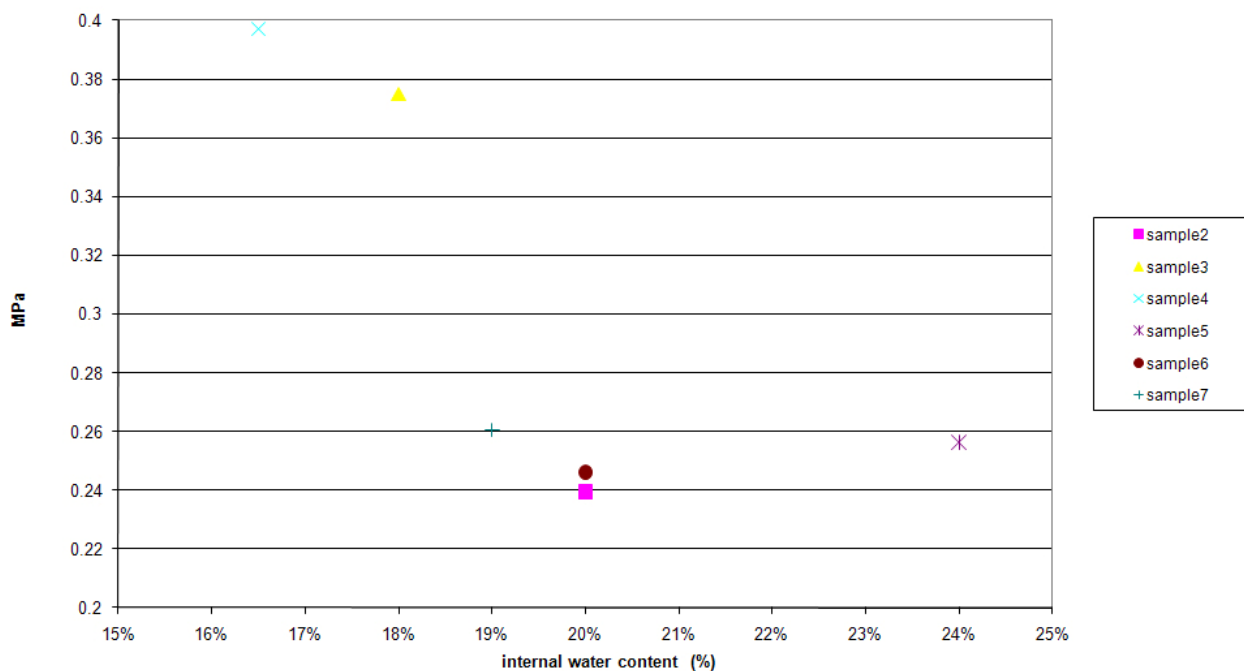
Figure 9. The dependence of the compressive strength on internal water content for each tested wall.

From Table 3, the *initial* compressive strength from all samples is 0.30 MPa. It is immediately possible to note that two walls show a higher maximum compression stress than the others. This can surely be explained by looking at Figure 9, where ω_{int} is related to σ_{\max} . An $\omega_{\text{int}} \approx 19\%$ seems to be a low limit below which compression strength rapidly increases. Thus, if we take apart wall 3 and 4, the *initial* compressive strength is 0.25 MPa. Instead, for wall 3 and 4 the *initial* compressive strength is 0.39 MPa, which is more than 50% the previous *initial* compressive strength. All these values are clearly much lower than those expected for common unstabilized raw-earth constructions (about 2 MPa), even if there are not so many and such detailed data for raw-earth cob constructions [24].

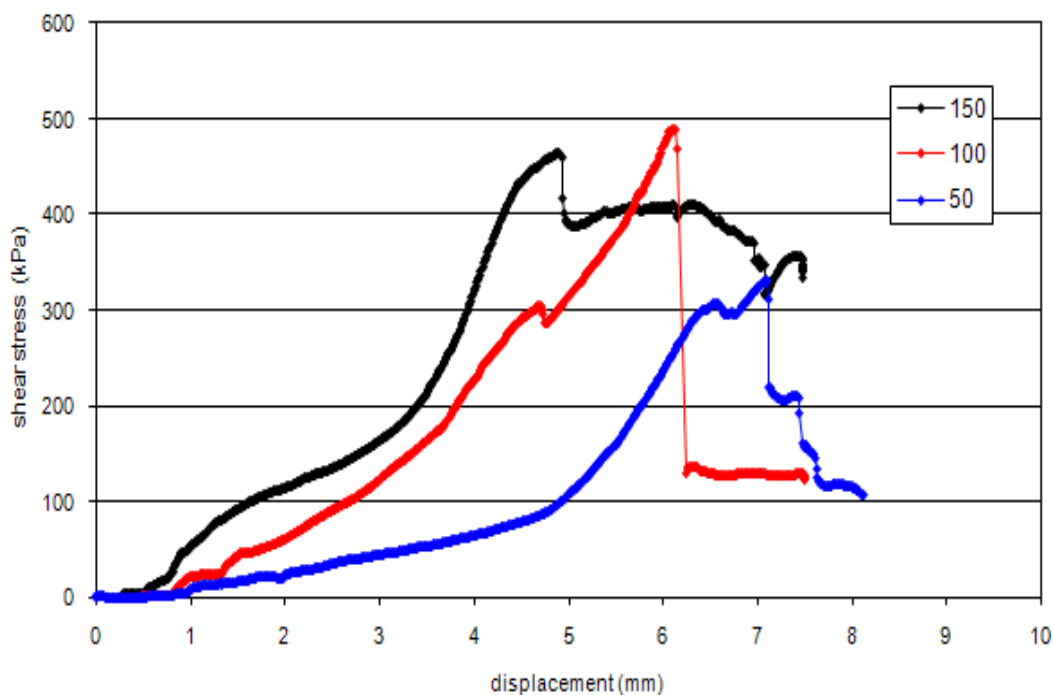
Figure 10. Shear stress-displacement relationship for DD-samples for a constant vertical compression of 50, 100 and 150 kPa.

Figures 10 and 11 show the relationships between applied shear stress and its related displacements for DD-samples and WD-samples at different constant compression stresses.

For DD-samples, the contact adjustment phase corresponded to the start of loading (≈ 1 mm). This lag probably depended on the non-perfect contact of the soil specimens with the internal metal faces of the Casagrande box due to its shrinkage by seasoning. Anyway, after this phase, the shear strength reached sharp peaks that seemed to be not influenced too much by friction (that is, cohesion played the most important role), reaching high values between 0.3–0.5 MPa; values that are similar to those found for common unstabilized raw-earth constructions (about 0.5 MPa) even if not explicitly for cob constructions [24].

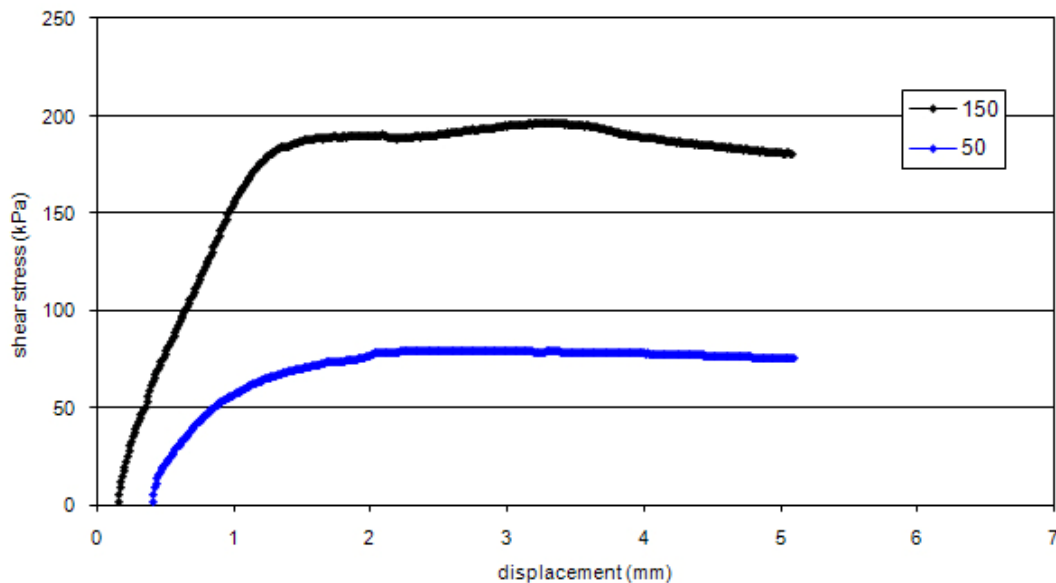
Figure 11. Shear stress-displacement relationship for WD-samples for a constant vertical compression of 50 and 150 kPa.

WD-specimens instead showed a smoother and lower shear strength, as expected, which was, however, high (0.07–0.20 MPa) if we consider that a half-specimen is wet. In this way, it can be reasonable to suppose that these values could be increased when straw is present and above all when the moistened cob bricks will start to dry.
