THE USE OF BUILDING LIMES IN ECOLOGICAL CONSTRUCTION

PART 2

STAFFORD HOLMES: CASE STUDIES

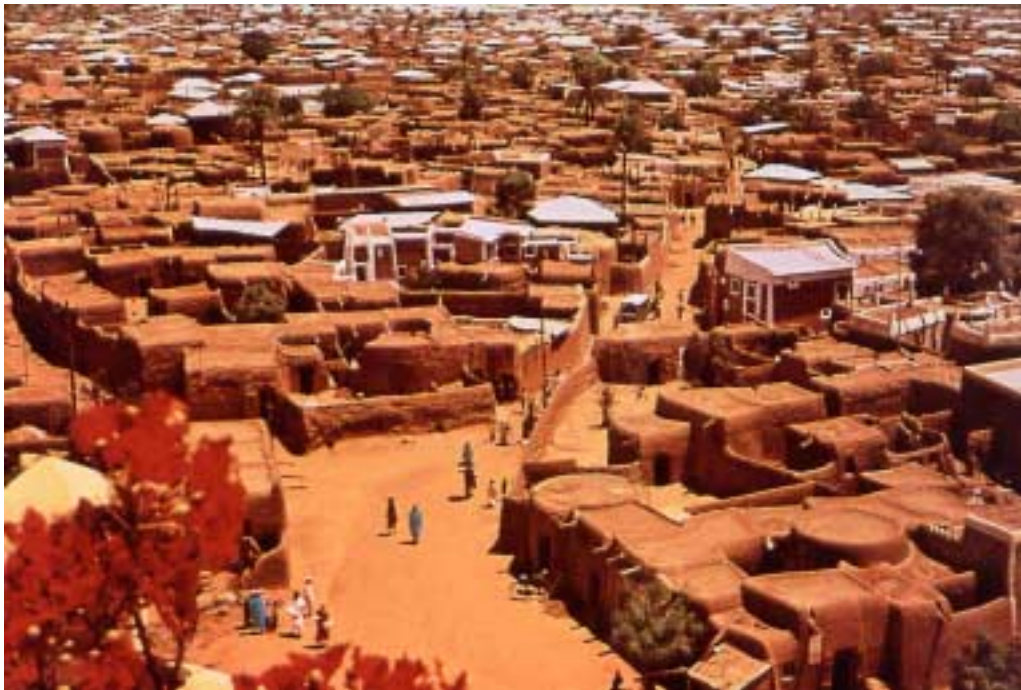
Slide 16 – Kano City

A view of Kano City, the state capital, from one of the mosque minarets. The traditional buildings of this walled ancient city are constructed of local lateritic soil. This is a red soil found in the tropics often, but not always, clay rich and with a ferrous content. The principal load bearing structural walls are built up by hand with the laterite in a damp state which is then allowed to dry. The nature of laterite is that it is pliable when wet but when dried it becomes

hard and durable. Roofs are usually flat or domed and constructed of the same material reinforced with joists cut from palm logs.

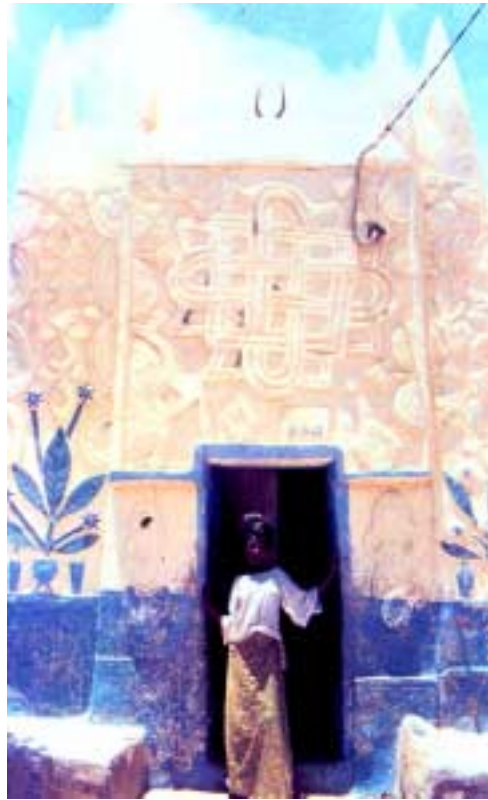
Slide 17 – Hausa Vernacular Architecture

Traditions, built up over centuries, are reflected in the architecture of the Hausa in northern Nigeria. Colours, patterns, texture and materials are combined to produce an organic architecture with its own special delight and identity. The laterite construction is suitable for the climate and weathers well in dry conditions. The buildings provide a cool environment during the day. During the short rainy season, however, close attention is required to repairs and maintenance. There are techniques for protecting the earth structures against damage by heavy rain which include the introduction of organic oils but the traditional crafts and skills required are dying out.

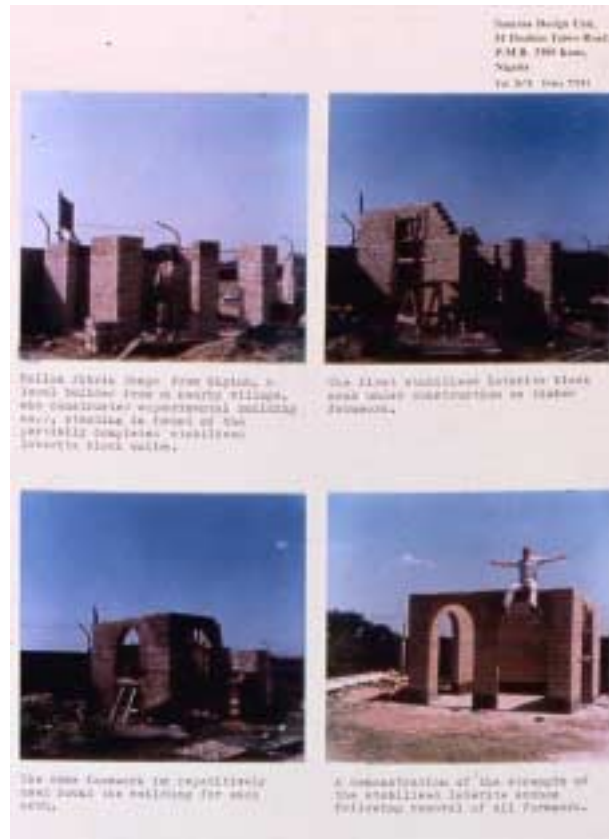
Slide 18 – Earth Stabilisation

In 1978 research was carried out on methods of stabilising the local lateritic soils with a view to conserving this unique architectural vernacular. The most readily available stabiliser was Portland cement. A range of standard sandcrete block making machines was also available and one of these was adapted to vibro-compact solid stabilised laterite blocks. The blocks were tested by immersing them under water for 28 days. Three types of laterite were examined to determine the minimum cement required for stabilisation. This ranged from between 7% down to as little as 3%. An experimental building was constructed to demonstrate the viability of this process.

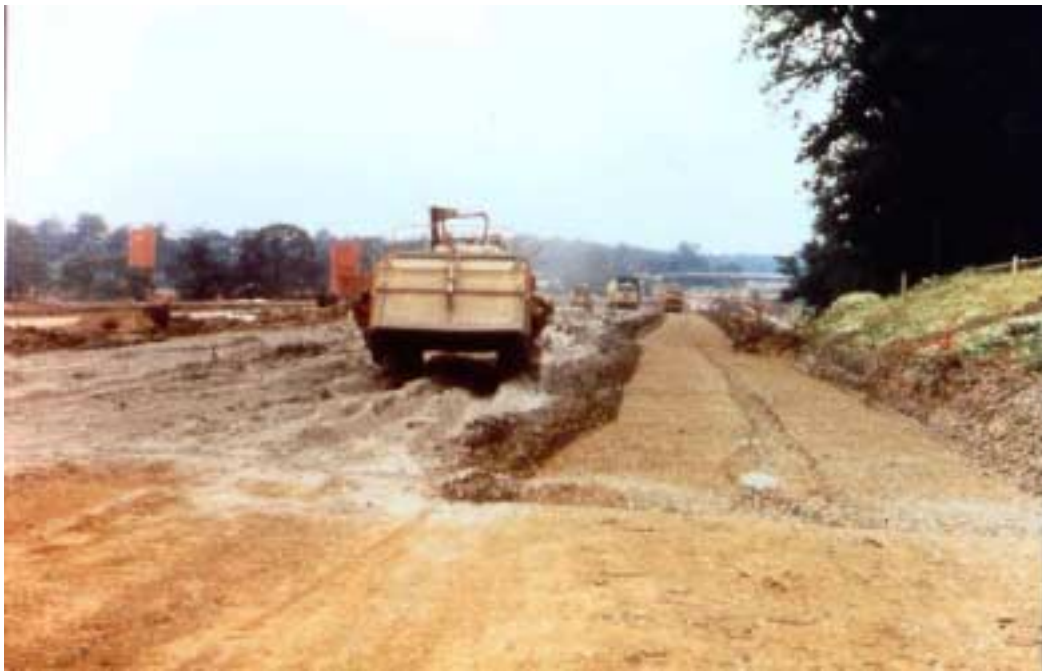
Slide 20 – Construction of the M25 London Orbital Motorway

The last section of the six lane motorway orbiting London was constructed with a road sub-base of lime stabilised soil. Road engineering principles of stabilising clay rich soils with lime are well established and have been practised in America and Europe for the construction of airport runways and roads over the last 50 years.

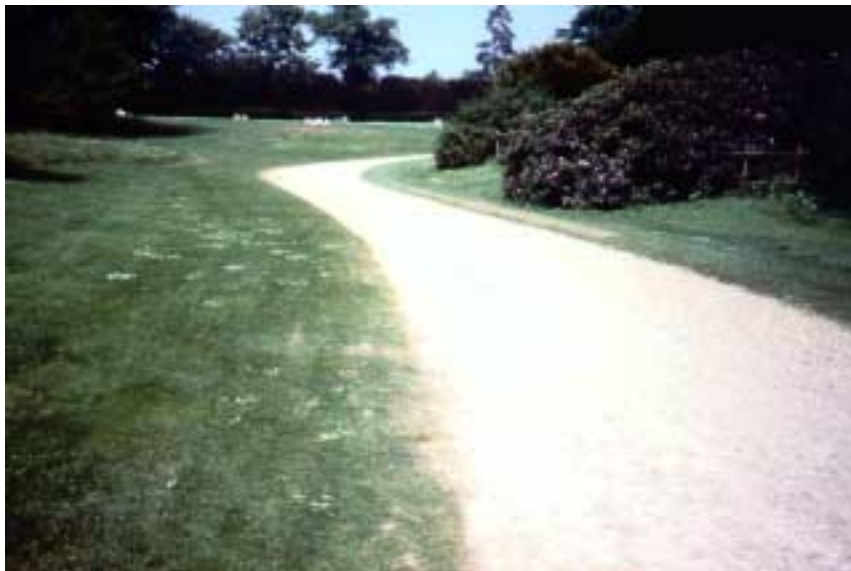
Slide 22 – Warwick Castle Estate Road

Not quite the size of the M25! Learning from the construction of the M25, however, the Estate road was rotavated to a depth of 6" and approximately 5% quick lime added for stabilization. This was compacted and the finished result gave the desired appearance and quality for an Estate road in the grounds of a medieval castle. The road was used unsurfaced for approximately 5 years following which, due to increasing traffic, it was decided to surface dress. The sub-base and wearing surface are still in use today.

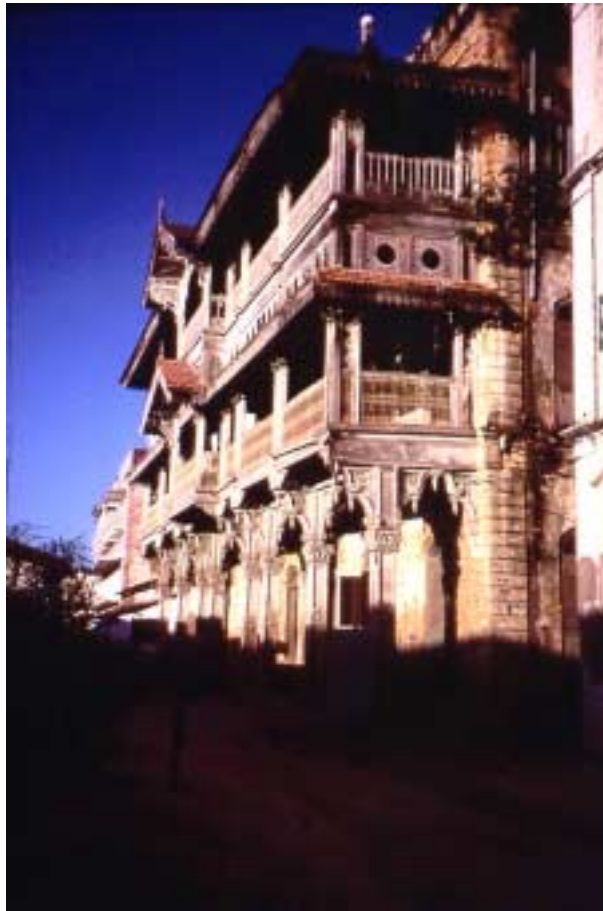
Slide 23 – Ithnashery Dispensary, Zanzibar

Construction of this remarkable building commenced in 1887. The timber balconies disguise the main construction which exemplifies the conservative use of lime in conjunction with other materials. Unfortunately, due to major political change and subsequent neglect of the drainage

system over the last 30 years, lack of maintenance caused major deterioration. The building has now been renovated by the Agah Khan Trust.

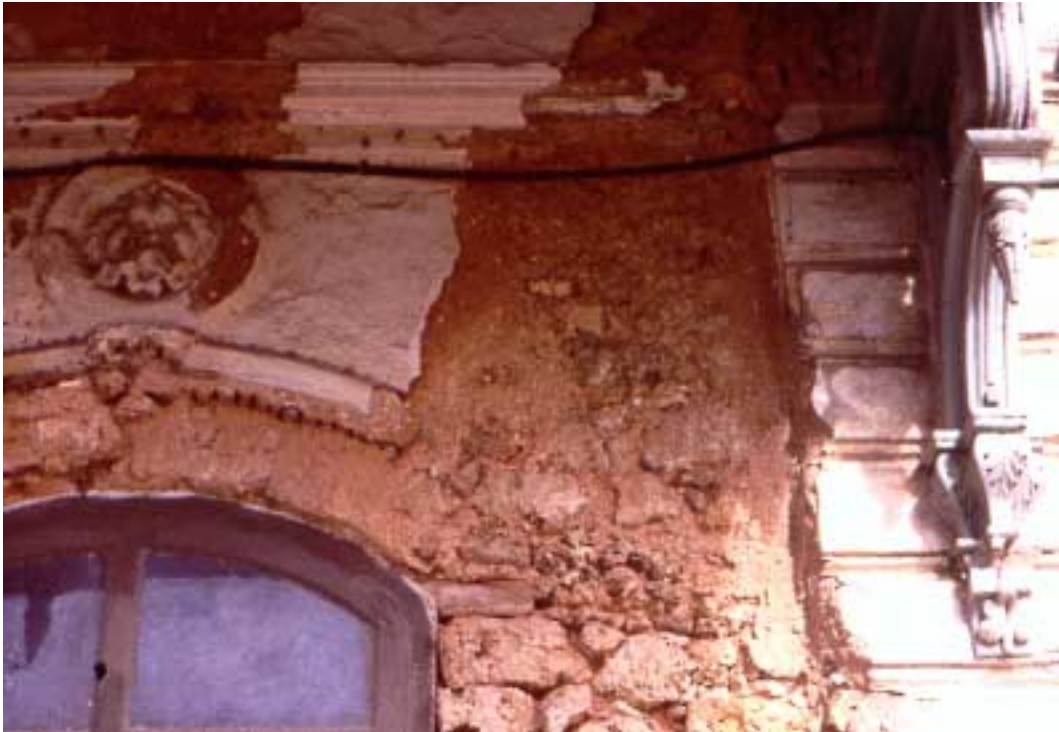
Slide 24 – Typical Zanzibar Construction

Erosion on the front elevation of the Ithnashery Dispensary reveals the construction method of roughly dressed coral ragstone set in lime stabilised lateritic mortar. This forms the structural base and background for the lime stabilised lateritic render. The same mix is used both as a base coat for the plain render and for relief modelling which is supported on nail armatures. The decorative work of the corbel below the timber balcony support is executed in lime stabilised earth stucco. The rendered and modelled surfaces are then finished with an almost neat lime render skim and limewash.

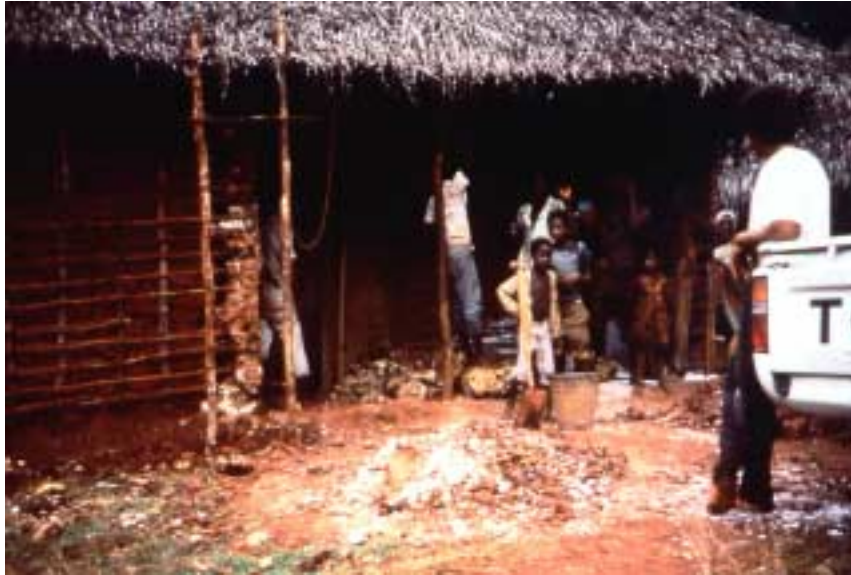
Slide 25 – Building with Lime

A current practice when building houses in rural areas of Zanzibar is to add hydrated lime to the lateritic earth before daubing it into a double framed lattice of saplings. This construction is used for both external walls and internal partitions which are protected by the palm frond thatched roof above.

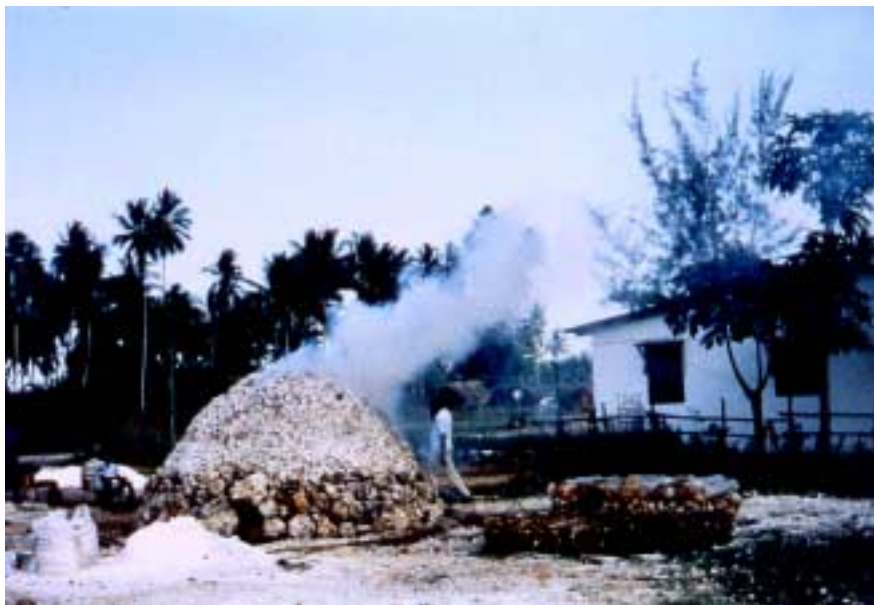
Slide 26 – Small-Scale Lime-Burning

Lime is still being burnt in Zanzibar on a small-scale today. The traditional method consists of heap burning small pieces of broken coral ragstone on a circle of palm tree logs.

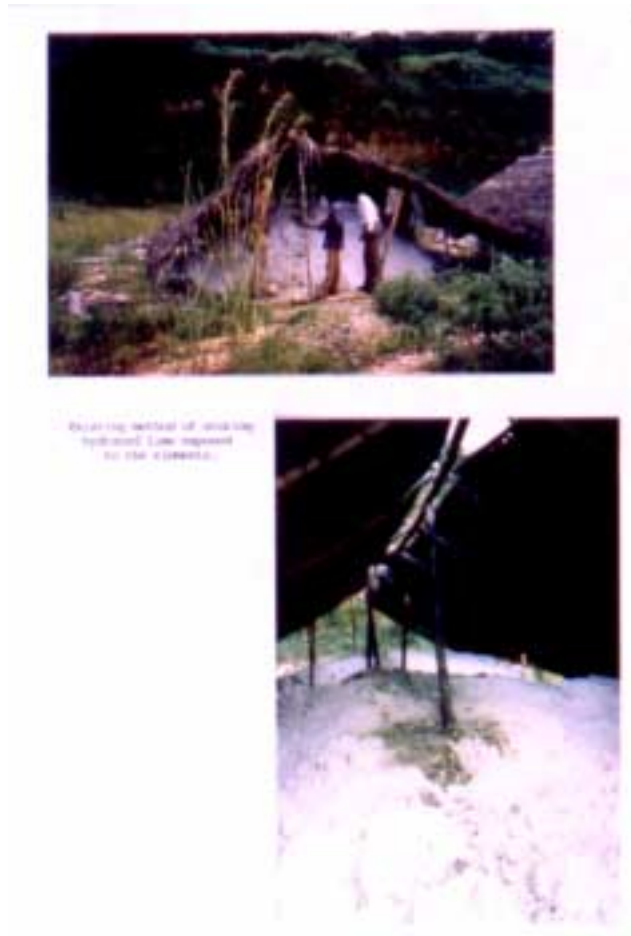
Slide 27 – Lime Hydrate

After burning the quicklime is slaked to a dry hydrate and stored in a heap under an open thatched canopy. Stored like this the hydrate air slakes, particularly over a long period in a hot, moist climate and loses its binding properties. Following a request from the Zanzibar Stone Town Conservation and Development Authority, we gave advice on behalf of the Intermediate Technology Development Group. During the training and demonstration courses we advised on ways in which lime production could be improved and the lime stored to ensure optimum quality and to maintain its binding properties.

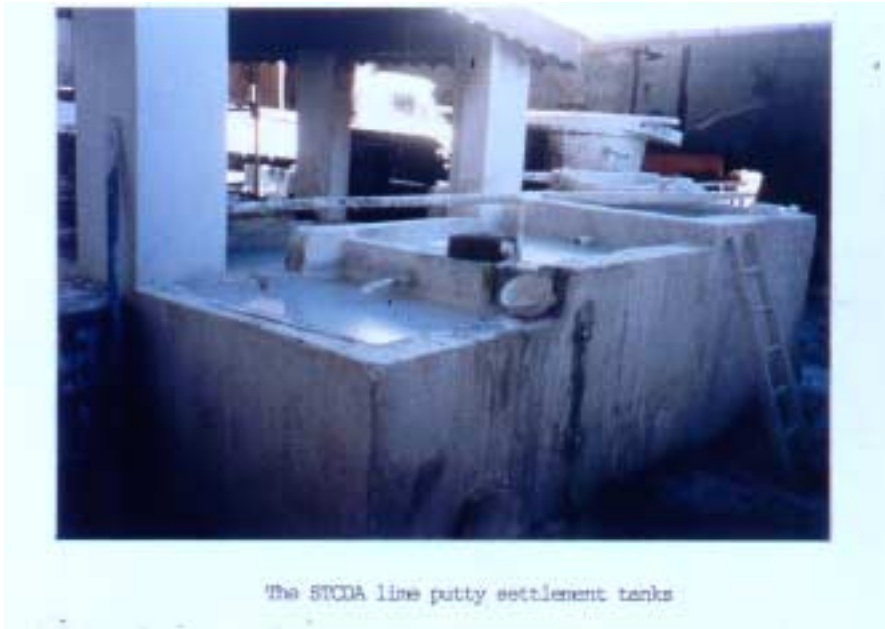
Slide 28 – Slaking to Putty

The advice given to improve the end product was to slake the lime to putty. This was demonstrated on the first visit by using empty oil drums as slaking vessels. Subsequently, the STCDA built their own slaking tanks.

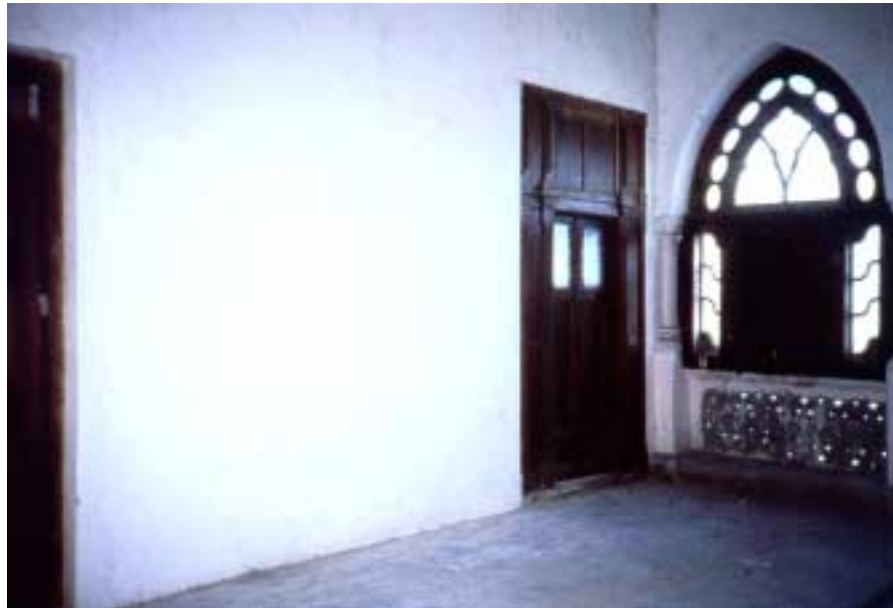
Slide 29 – Bharmal Building Plaster

The lime putty produced by the Authority mixed with sand made good lime plaster. This illustration shows the successful lime plaster wall finish inside the Bharmal building.

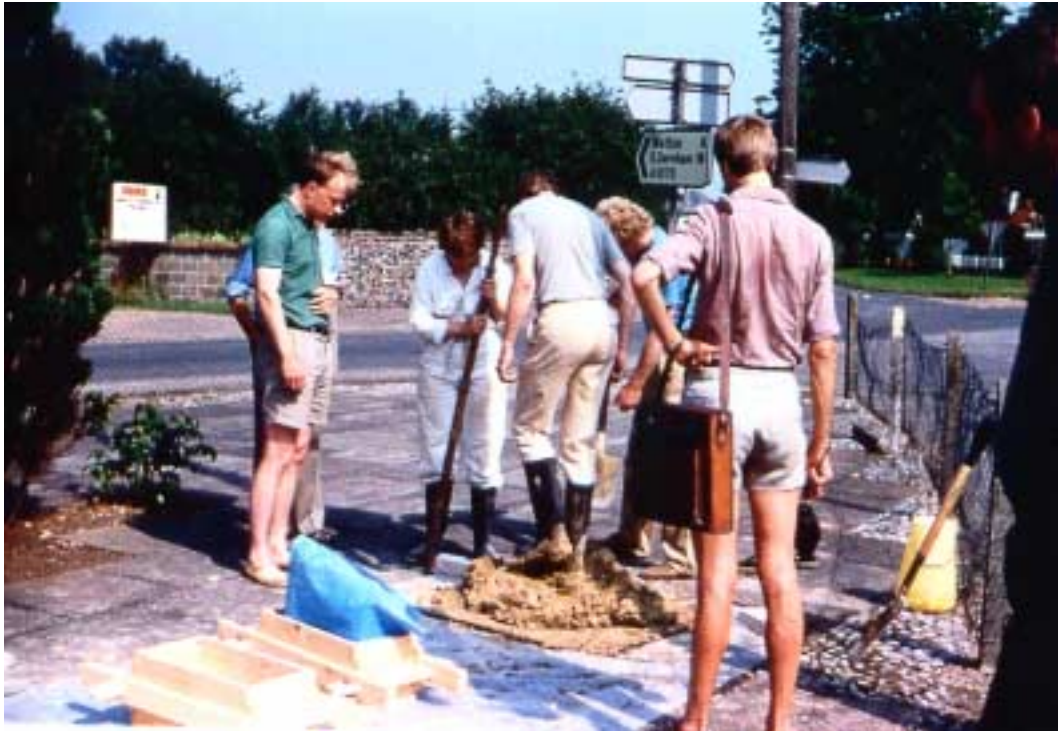
Slide 30 – Clay Lump Preparation in Norfolk

The SPAB (Society for the Protection of Ancient Buildings) organised a clay lump day in Norfolk to demonstrate clay lump construction techniques. This is a common traditional form of construction used for many of the older buildings in the area. It is often unrecognised due to the practice of rendering and painting externally and plastering internally. Clay lump construction techniques had almost been forgotten and it was important to relearn these if repairs were to be successful. Existing clay lump was analysed and the mix reproduced. The ingredients and their proportions tend to vary from one part of the county to another, but mainly consist of clay, silt, sand and coarse aggregate with some straw or cow dung as a binder. The mixture may or may not contain a small proportion of chalk and lime. The demonstration course showed mixing the ingredients to the right consistency by watering and treading in and then compacting the clay lump in moulds.

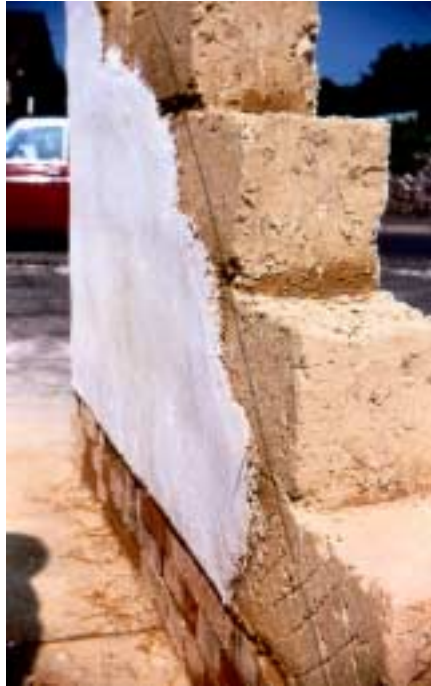
Slide 31 – Clay Lump Wall Construction

Construction of clay lump walling was demonstrated by bedding the dried lumps (blocks) onto a solid base and to each other with a clay lump mortar, rendering the face with a clay lump render of a similar mix and finishing the surface with limewash.

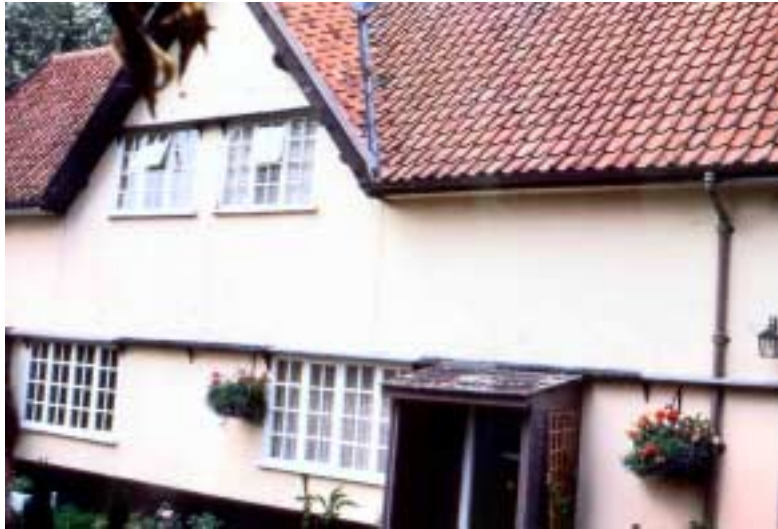
Slide 32 – Clay Lump House, Norfolk

A clay lump house built in Norfolk in the 1930s completed with render and painted. This is difficult to distinguish from many other rendered houses constructed with more “conventional” materials.

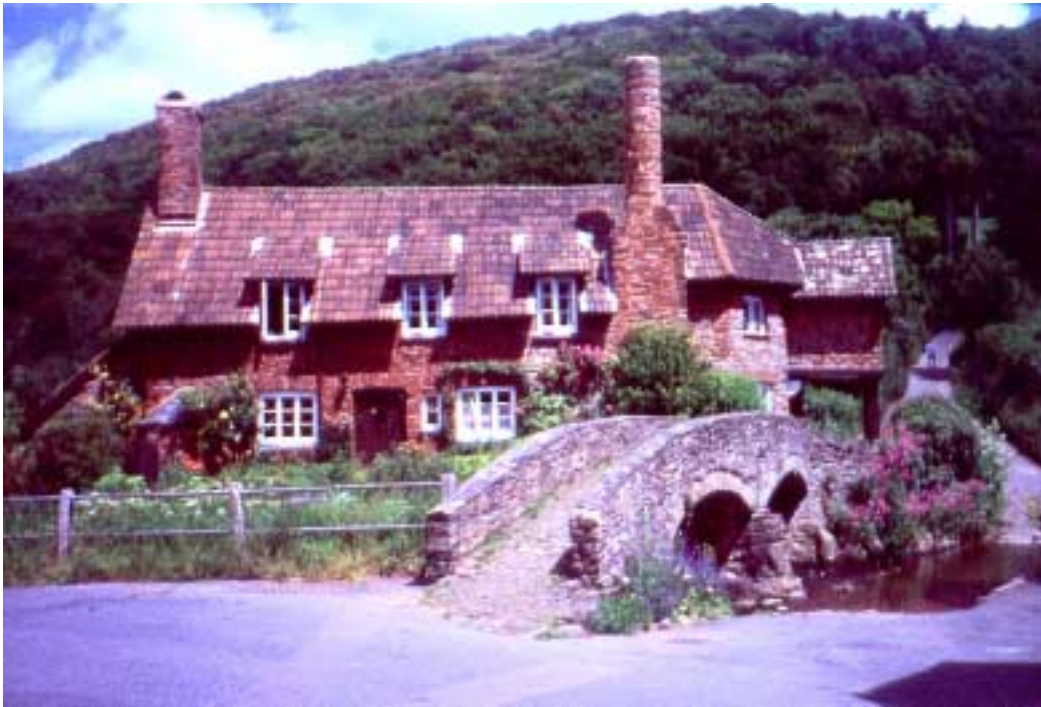
Slide 33 – Holnicote Estate, Somerset

This house and Packhorse Bridge at Allerford typify traditional construction methods found throughout the Holnicote Estate. Probably from Saxon times or earlier, the area has been largely self sufficient and its buildings exemplify the use of local resources. The house is constructed of local sandstone and was originally thatched with local reed. The timber used is from the Estate forests and the sand for the mortar was taken from the adjacent river. An outcrop of blue lias limestone at the centre of the Estate completes a full compliment of building materials.

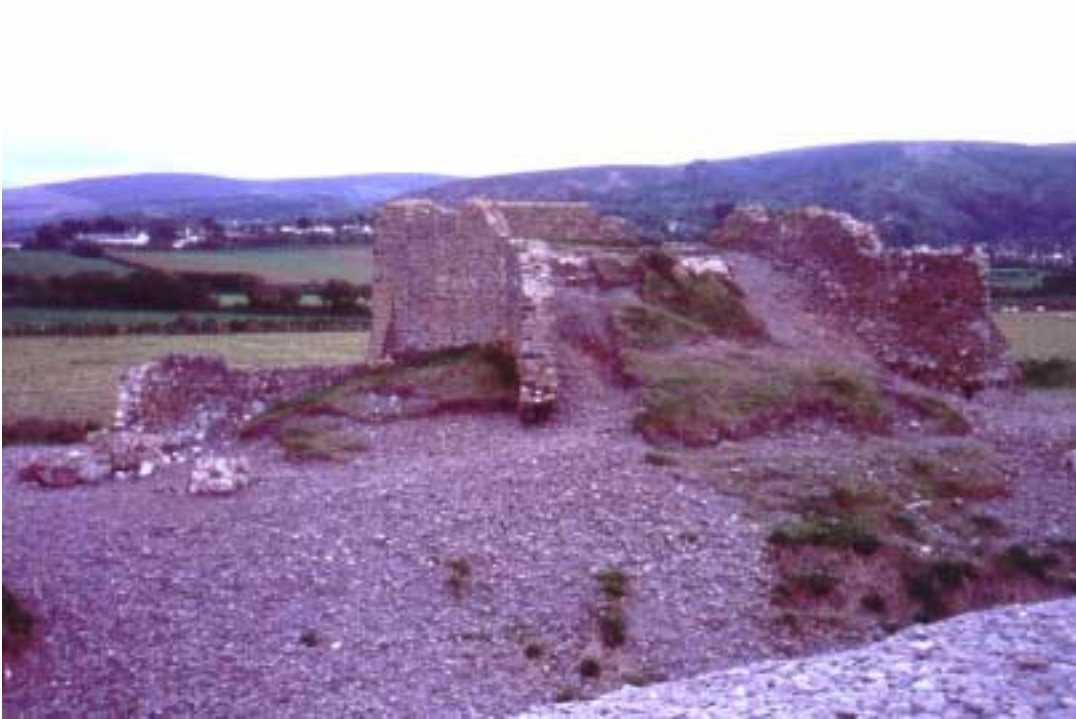
Slide 34 – Bossington Lime Kilns, Holnicote Estate

Similar to many parts of England where limestone is present, the Estate contains the remains of a number of lime kilns. These indicate the importance of lime production to the local economy. Over the centuries lime has been used for a wide range of industry, for agriculture and for building. Most kilns were small-scale by today's standards and usually built of local materials. This kiln is located at the edge of the beach and is constructed of beach boulders and stones bonded with blue lias hydraulic lime mortar.

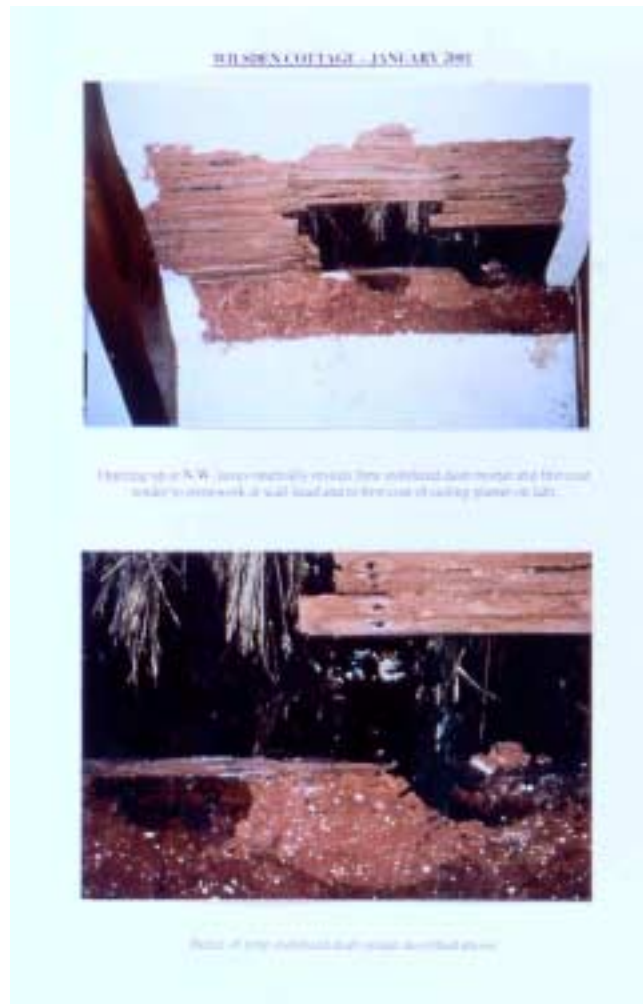
Slide 37 – Wilsden Cottage Daub Plaster

Overdue thatching repairs resulted in holed thatched and subsequent damage to the roof timbers of Wilsden Cottage. When the damaged areas were carefully opened up from the inside for inspection prior to repair, stabilised clay daub plaster to all interiors was found together with a similar material used for bedding mortar and ceiling plaster. Prior to opening up the presence of this material was not known as it was covered by lime plaster and limewash finishes.

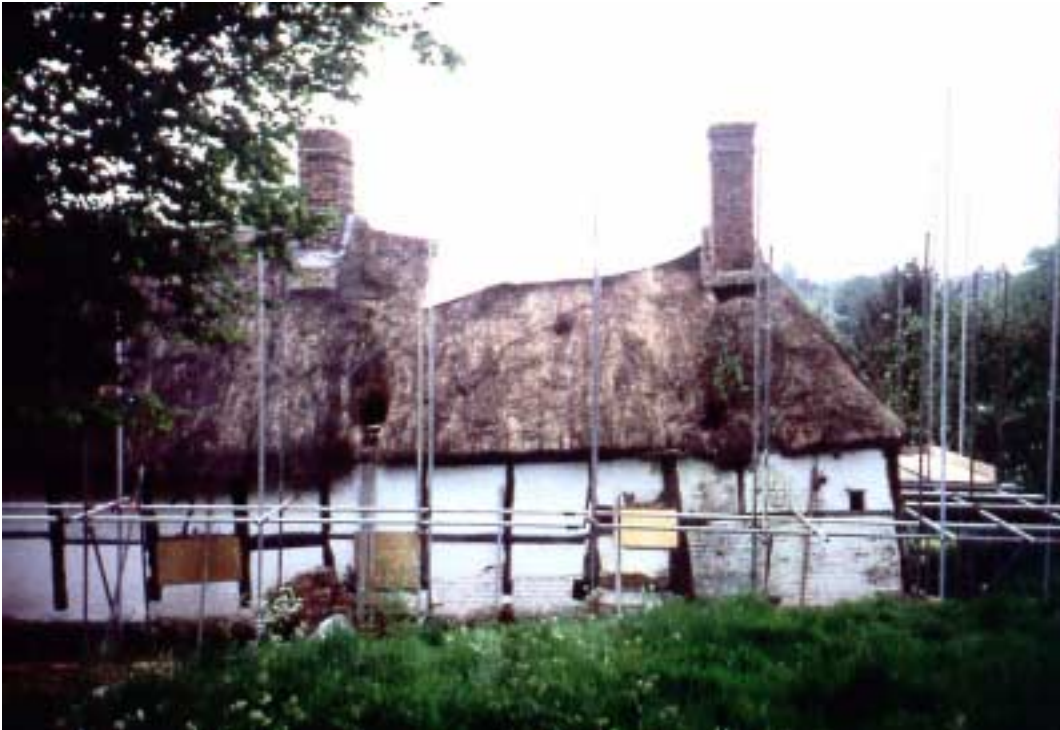
Slide 38 – Motslow Hill Cottage Prior to Repair

This is a 16th century timber framed building. The new owners, Mr. & Mrs. D. Anderson, were anxious to ensure that entirely compatible and traditional materials were used for its repair after purchase. The cause of much of the damage was lack of maintenance particularly to the thatched roof which was holed in a number of places. Again, water damage from the leaking roof had caused severe rot to structural timbers. Due to the extent of thatch decay and timber repairs required, it was decided to carefully strip the existing and re-thatch.

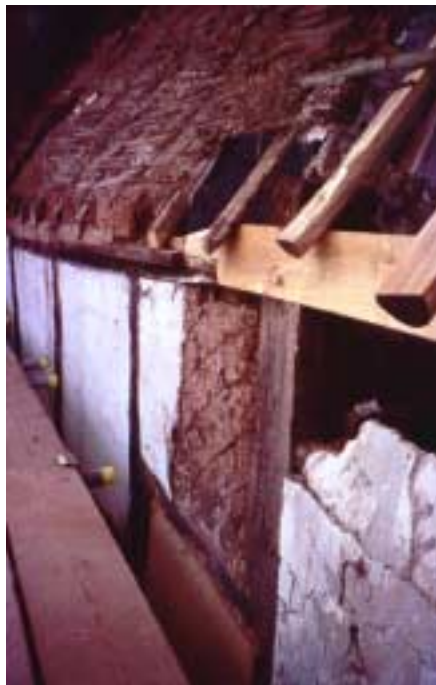
Slide 40 – Wattle and Daub External Wall Panels

The timber frame and rafters were repaired with English Oak of similar section to the existing where water damage had occurred. All the infill panels on the front north wall had been replaced gradually over previous centuries with local brick. This had not been done, however, on the rear south elevation where complete wattle and daub panels have survived. Some of the panels had been coated over with Portland cement based mixes or infilled with concrete blockwork and cement render. Defective wattle and daub panels were carefully repaired using material to match the original which included quicklime stabilised clay daub on wattle, lime render skim coat and a limewash paint finish.

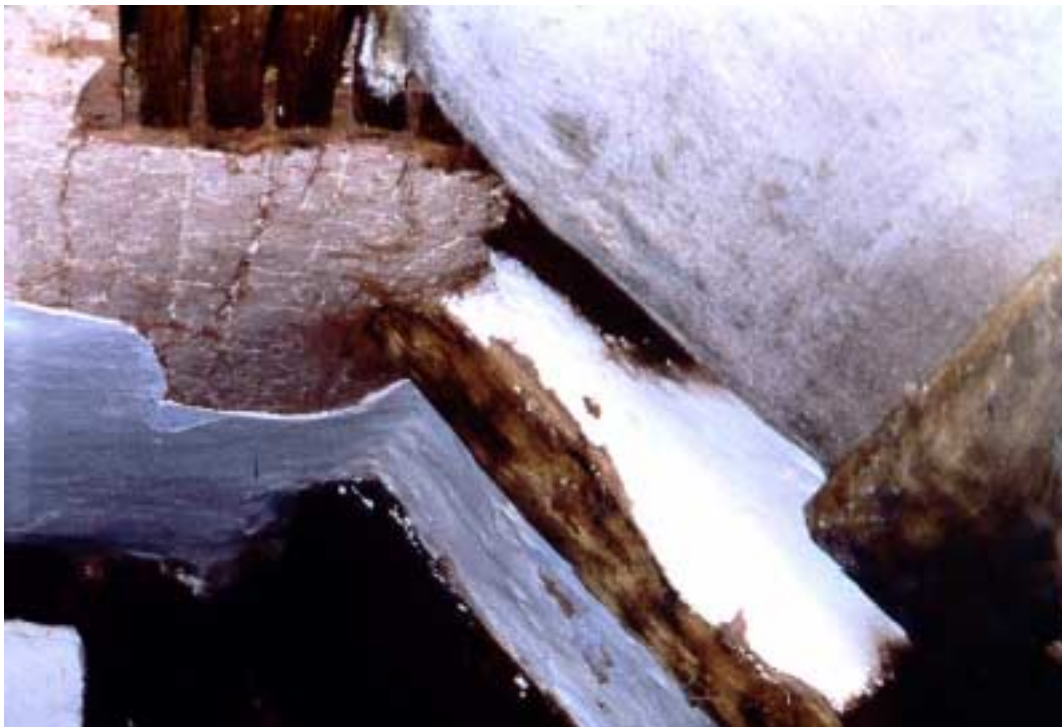
Slide 41 – Existing Interior Finishes

A view of the first floor ceiling reveals lime skim coats or limewash on clay daub ceiling plaster on riven laths which are fixed to the round oak rafters. A limewash finish had been taken across all interior timbers.

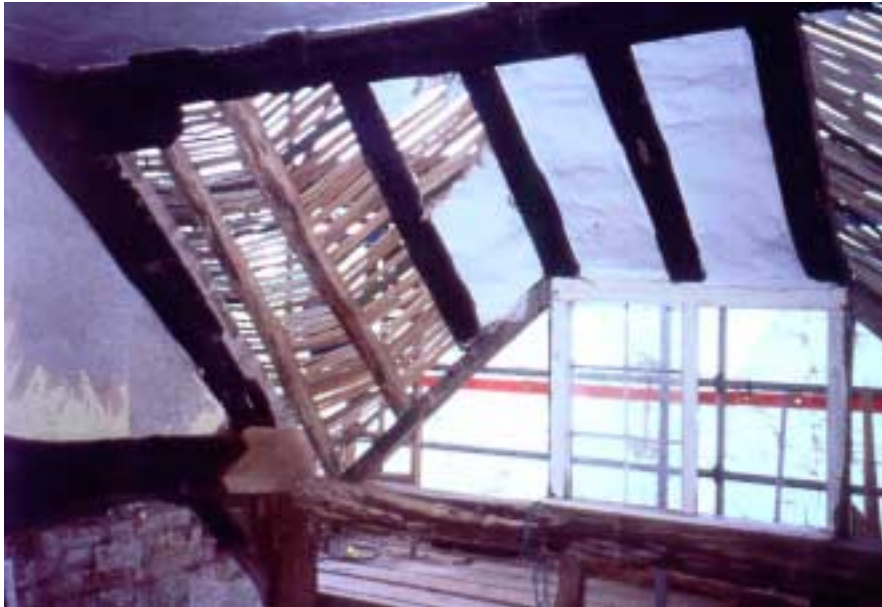
Slide 42 – Conservative Roof Repairs

An interior view to the underside of the roof and dormer window showing repairs with matching timber structure and rafters hand finished with an adze, and riven laths for the plaster support. The sound existing daub plaster and limewash finish has been carefully retained.

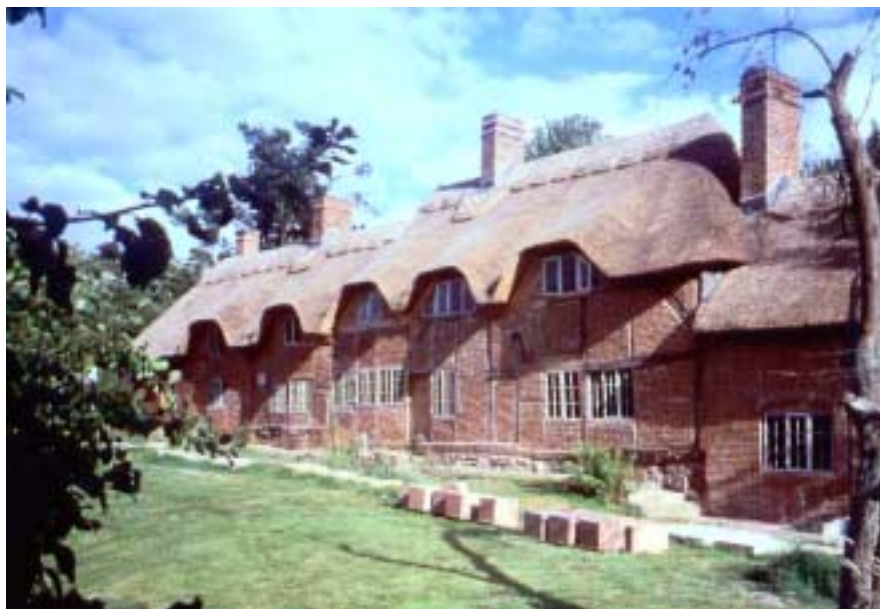
Slide 43 – Completed External Envelope

A view of Motslow Hill Cottages from the north following re-thatching and repointing of brickwork with a lime mortar using local sand. The external envelope was completed first to assist protection of the building fabric and drying out prior to all internal repairs which were treated as a second and later phase of the project.

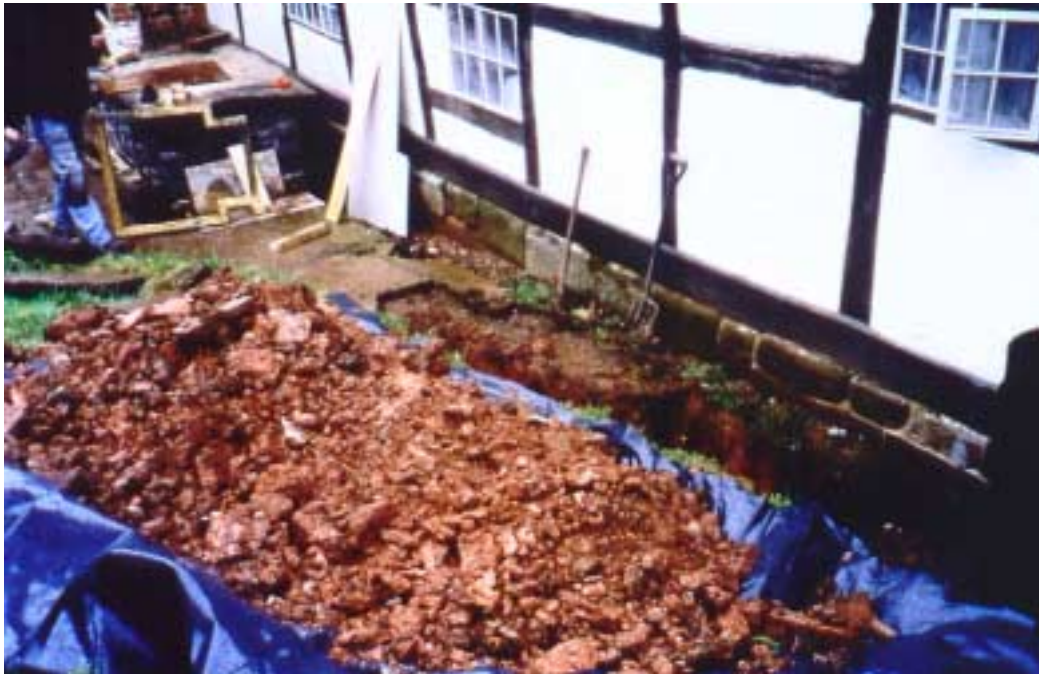
Slide 44 – Local Clay

The second phase of repairs included installation of new bathrooms and drainage. Excavation of the drainage trenches revealed a rich clay subsoil closely matching, and presumably used for, the original daub. In order to prepare the daub for repairing the external wattle and daub panels, the material was mixed by hand, including the addition of 5% quicklime. This was heavy manual work but not a major problem due to the relatively small quantity required. When it came to Phase 2, however, the extent of repairing and replacing plasterwork to the interior ceilings and walls was another matter! The plasterers, Trumpers Limited, experimented with mixing methods that were less labour intensive. Initially it was assumed that the clay daub would be too stiff and cohesive to be turned in a conventional drum mixer. During the course of trials it was found that provided the daub was well wetted to plastering consistency, this could be successfully mixed mechanically. The secret was to add the quicklime at the end of the mixing process and then to ensure continuous mixing for the minimum time to achieve a consistent and even distribution.

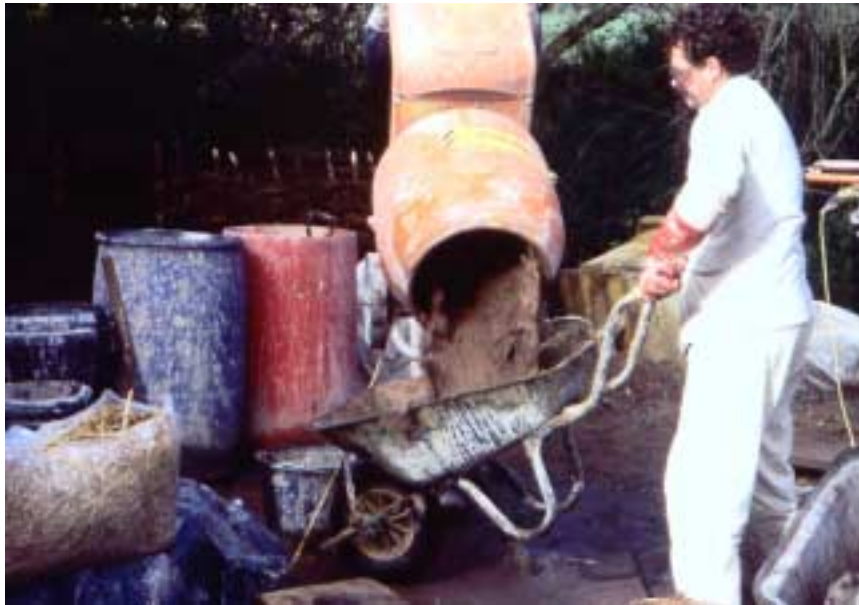
Slide 45 – Lime Stabilised Daub Production

Craftsmanship skill and experience is needed to judge the optimum plastering consistency. Trial and error and experience is part of the process of achieving the best results. It was found that a good quality mix of the correct consistency can be easily discharged from a standard drum mixer.

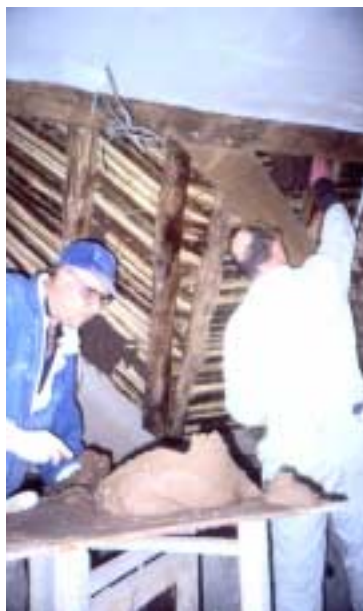
Slide 46 – Applying the Lime Stabilised Daub Ceiling Plaster

The daub plaster was applied to riven ceiling laths below the thatch in a similar way to normal lime plaster but with a thicker first coat. It is important that the daub is applied as stiff (dry) as possible to reduce shrinkage. The quicklime took approximately 15 to 20 minutes before its reaction with the clay was sufficiently marked to make the mix too stiff to work. By preparing the mix in one small batch at a time and using it immediately, there was just time to complete the plastering operation before the material became too stiff to work.

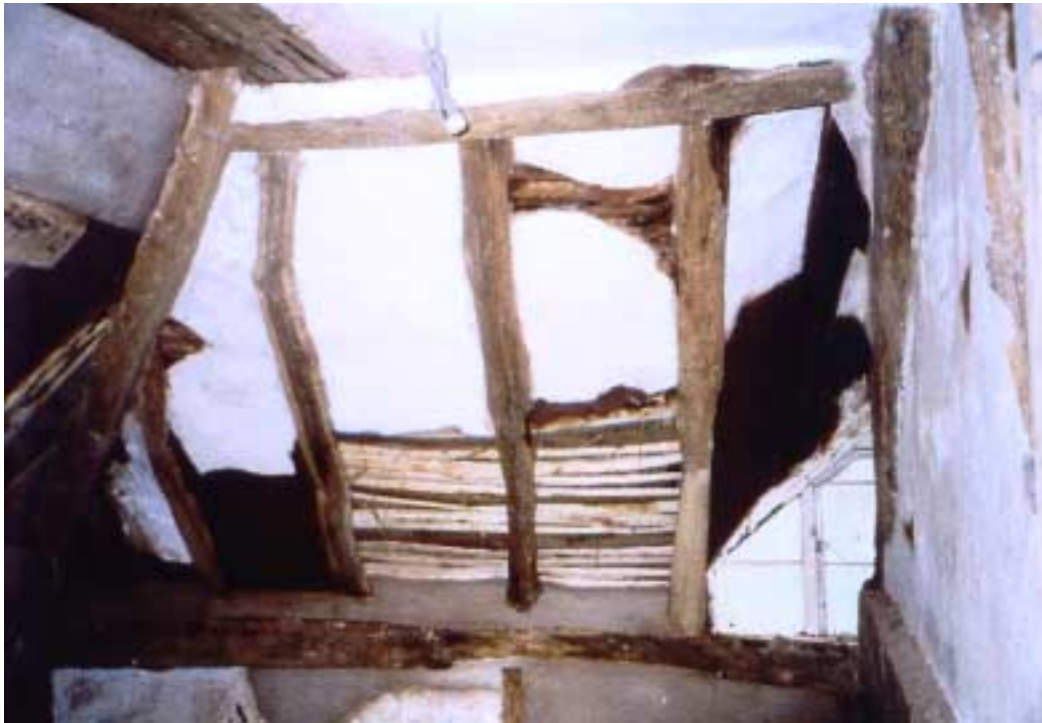
Slide 47 – Partially Completed Ceiling Repairs

The new plaster daub was matched into the existing on new and repaired riven laths.

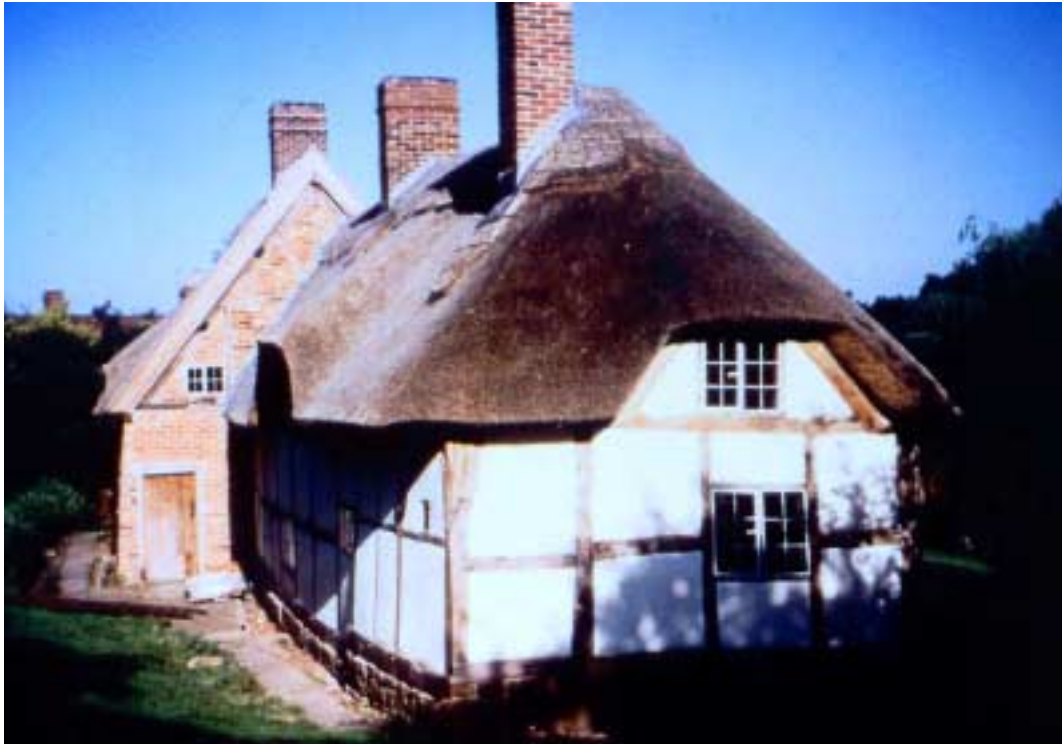
Slide 48 – A View of the Completed Building from the South-East

The majority of first floor infill panels are wattle and daub which have been retained. A consistent finish of limewash on lime render was given to all rendered panels and the sound existing lime plaster and wattle and daub panels were conserved.
